Quantum Home Inspections

Home Inspection Report

123 Any Street, Queen Creek AZ, 85243
Inspection prepared for: Sample Report
Inspection Date: 11/10/2008 Size: 2100 sft
Weather: Clear 60 degrees

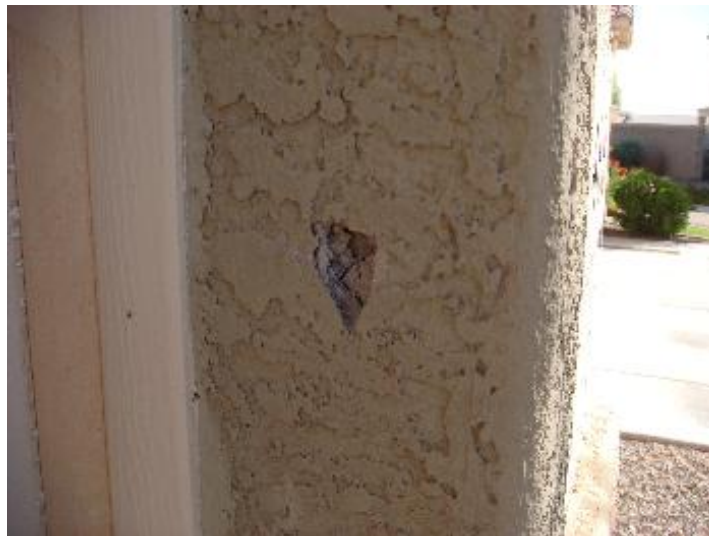
Observations: Common cracks noted. • Suggest trimming back vegetation from stucco to prevent deterioration of the stucco and help prevent water intrusion. • Hole in stucco with wire lath exposed near garage. Recommend repair to prevent water intrusion into wall structure. Repair by qualified personnel will help prevent deterioration of surrounding structures. • Damage to stucco with staining, and deterioration at drip edge line on rear patio cover.

Hole in stucco with wire lath exposed

Recommend repair and adjustment of drip edge by qualified personnel to insure proper water flow off low slope roof. Lack of proper repair can result in further deterioration of stucco and underlying structures.

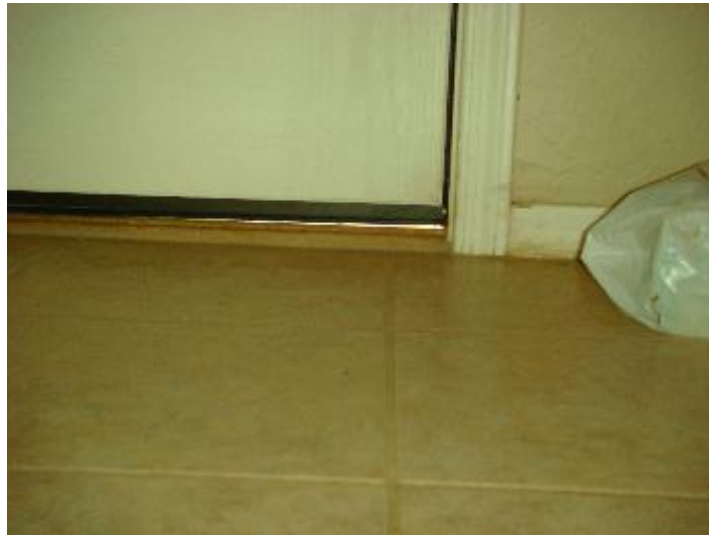
Observations: Weatherstripping appears to be missing/damaged/incomplete. Recommend replacement to decrease possibility of air/moisture infiltration.

Weatherstripping appears to be missing/damaged/incomplete. Recommend replacement to decrease possibility of air/moisture infiltration.

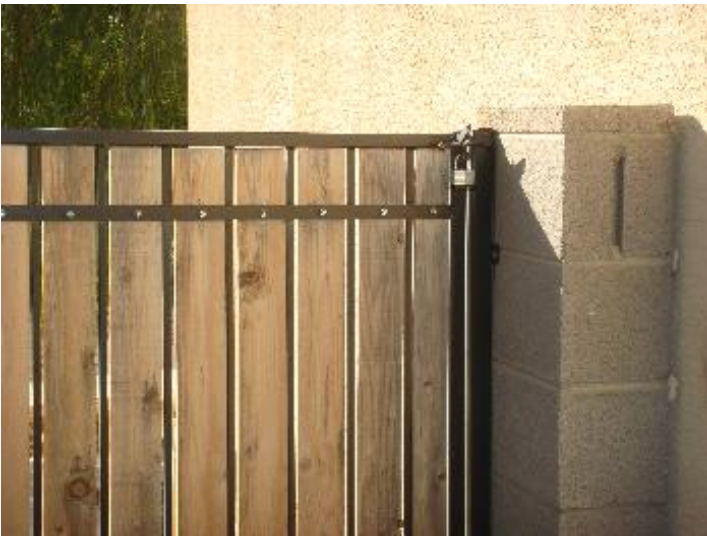
Exterior Fence Condition

Observations: Gates were locked at the time of inspection, did not operate. • Wood portion of gate is weathered with some staining. • Rusted piece of metal protruding from block fence east wall. Recommend repair by qualified personnel.

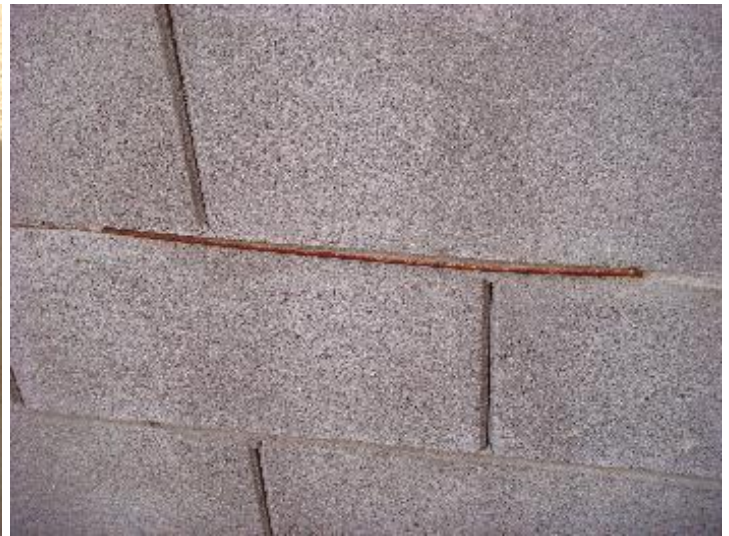
exposed metal on east wall

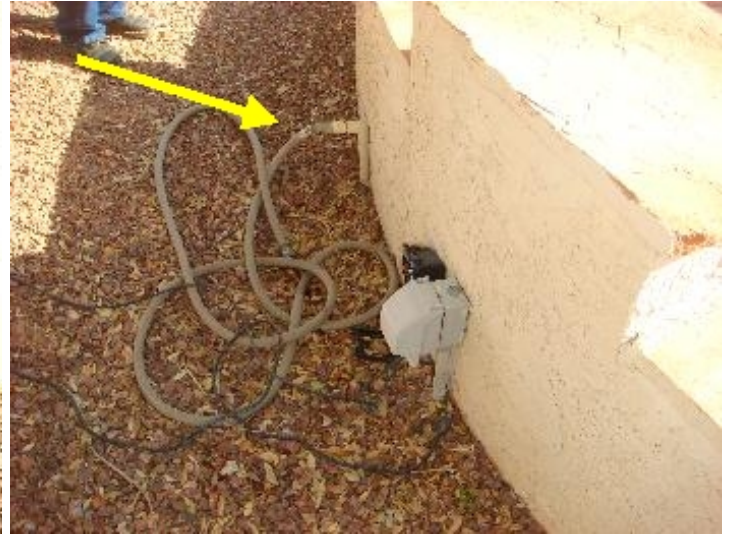
Observations: Faucet behind west seating area in backyard do not have an anti-siphon device installed. Recommend installation of anti-siphon device to prevent possible cross contamination of potable water supply.

No anti-siphon on hose bib.

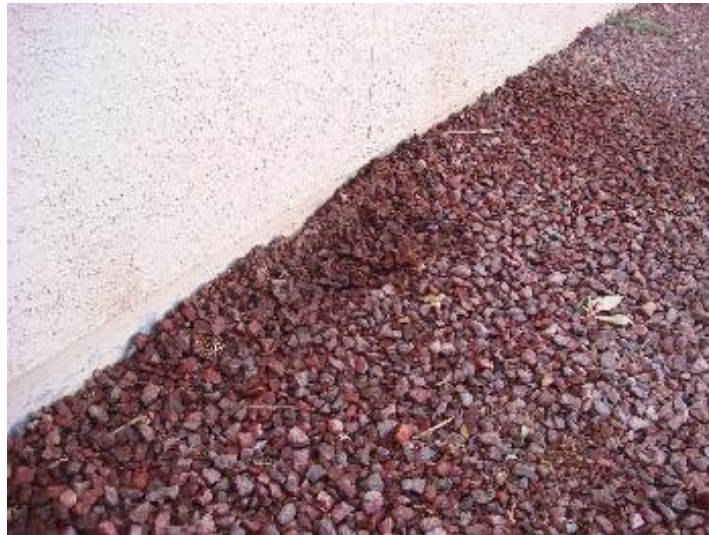
Observations: Entire slab not visible due to floor coverings. No readily visible problems. Floor coverings are not removed during the inspection • Common cracks noted in stem wall • Minor vertical cracking was noted. This cracking appeared typical of cracking that results during the curing process. Such "shrinkage cracks" are very common and are usually harmless. Should this cracking appear to worsen, consultation with a qualified contractor for required repairs is recommended. • Stem wall barely visible on west side of home. Grade too close to stucco. Recommend grade adjustment to allow 4-6" clearance of stucco from dirt. • NE portion of foundation in backyard has water saturated ground next to it. This appears to be from extensive flooding due to damaged sprinkler line next to stem wall. Soil is VERY soft in this area. Recommend evaluation of stem wall and rest of foundation in this area by qualified personnel. This condition could possibly lead to deterioration of slab foundation or sink hole formation affecting structure.

Extremely wet area with very soft ground

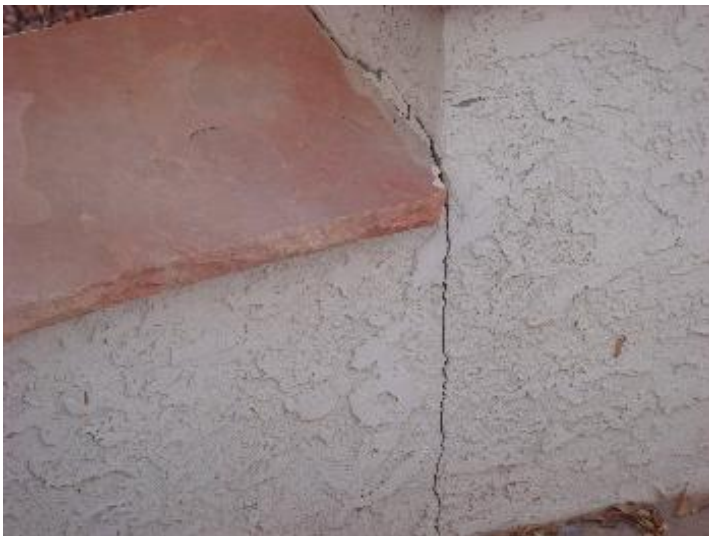
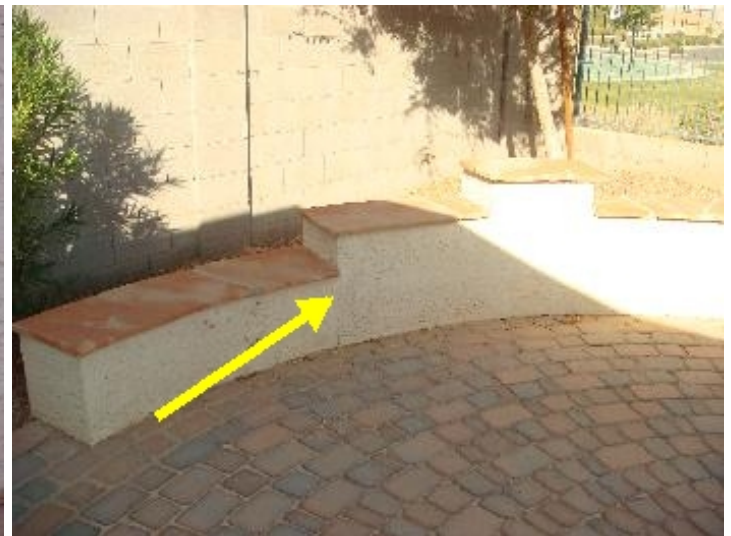
Observations: Common cracks. • Backyard has several sitting areas with pavers and stucco covered flagstone topped benches. • Stucco covered benches have chips, common cracks and large cracks in stucco.

Vertical crack through stucco on rear seating area

Recommend repair by qualified personnel to limit water intrusion into stucco and support structure.

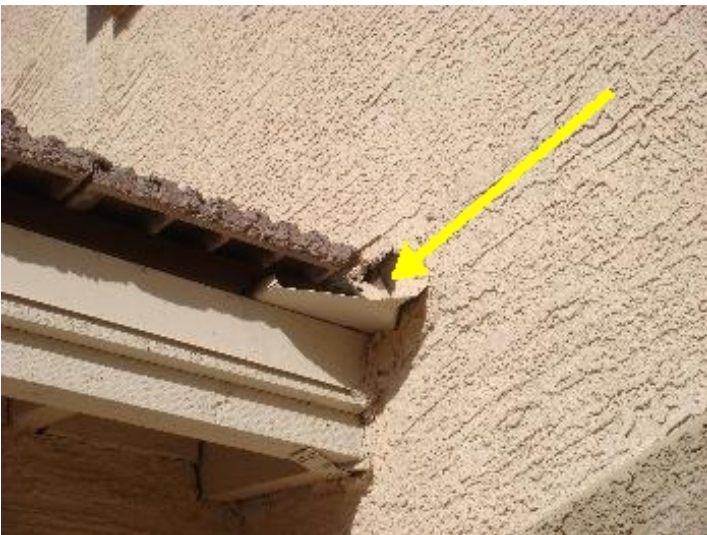
Observations: Metal kick-out damaged near garage door. Recommend evaluation for need of repair and functional ability.

Damaged metal in kick-out

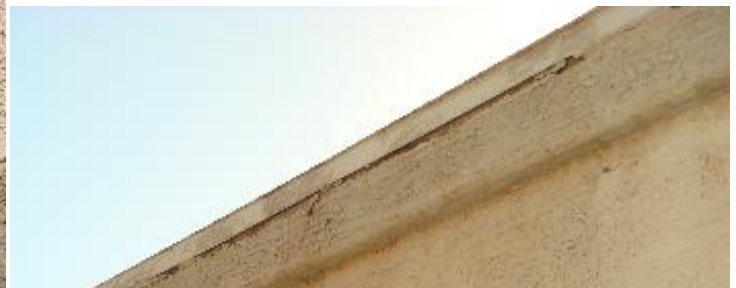
Stucco damage at drip edge on patio roof

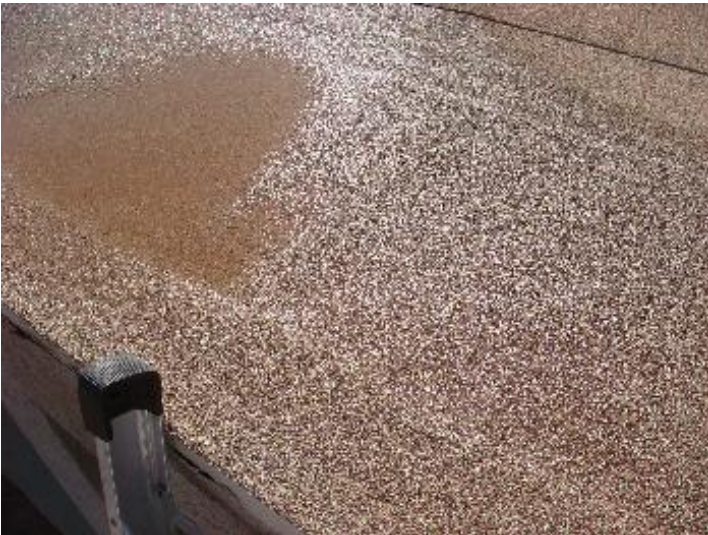
Ponding on patio roof

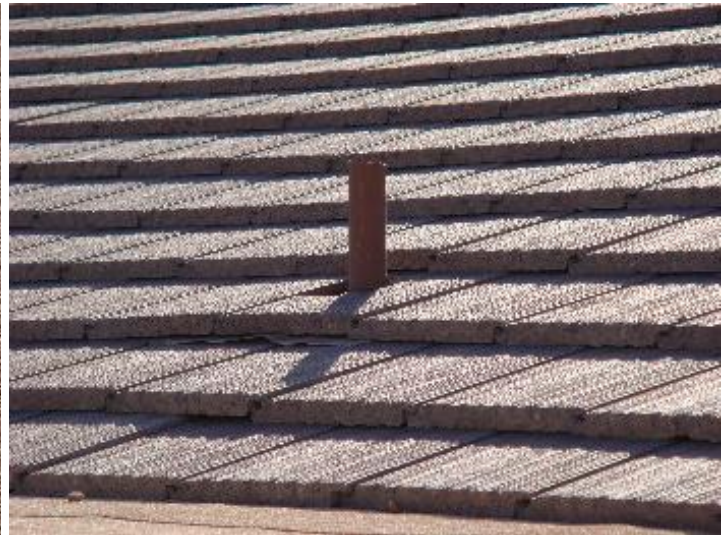
Observations: Several cracked tiles present. No evidence of water intrusion into attic at this time. Recommend observation of these tiles and underlayment for possible deterioration and repair/replacement. • * Unusual vent penetration through middle of tile. Flashing visible under tile however unable to determine proper installation. Recommend evaluation by qualified contractor. • Patio rolled roofing has ponding on surface. This is a potential area for water intrusion into patio roof structure. See information in Exterior section about drip flashing and stucco damage in this same area.

unusual vent penetration through tile

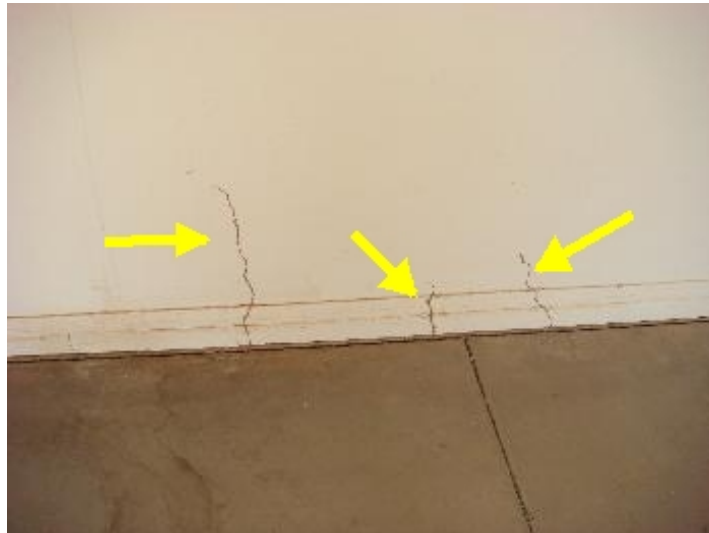
Observations: Noted are vertical brown stains and solid tubes. Recommend evaluation by licensed pest control company

Brown tube like structures on wall

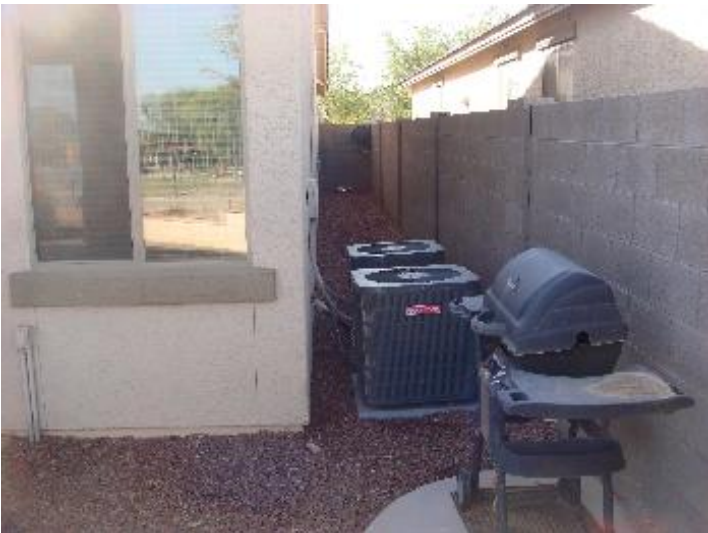
Observations: Air conditioning operational during inspection and appeared to be performing satisfactorily. Buyer is advised to verify satisfactory operation prior to close. • Air conditioning was only briefly tested due to outside temperature. Activating air conditioning during cool/cold weather can cause serious damage to the system. Buyer is advised to verify satisfactory operation prior to close. • Twin Goodman AC units one 2.5ton and other 3.0ton units installed on pads at the west side of home. • Air handler(s) appear serviceable. Coils appear serviceable. Condensation lines should be monitored on a regular basis for blockage. Blocked condensation lines may lead to moisture damage near the air handler(s). Condition of condensate lines in the walls and/or floors cannot be evaluated. • 240 volt electrical disconnect(s) present. • Refrigerant lines are not fully visible. • Ac units are not level. Recommend evaluation by qualified professional • Insulation installed on refrigerant lines near outside unit(s) need repair. • Electrical disconnects need proper clearance for service. Proper working space not present at these units. Recommend evaluation by appropriate professional.

A/C units not level

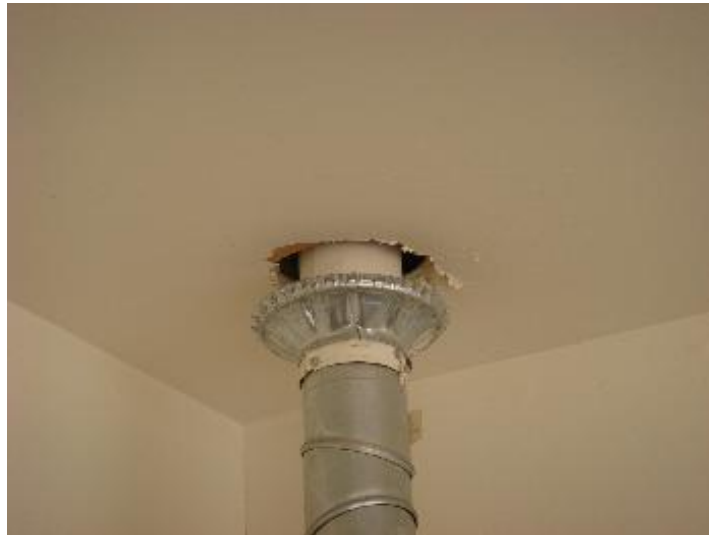
Observations: Vent flue piping not fully visible. • Vent flue collar is loose at ceiling. Recommend repair by qualified professional.

Vent flue collar is loose at ceiling. Recommend repair by qualified professional.

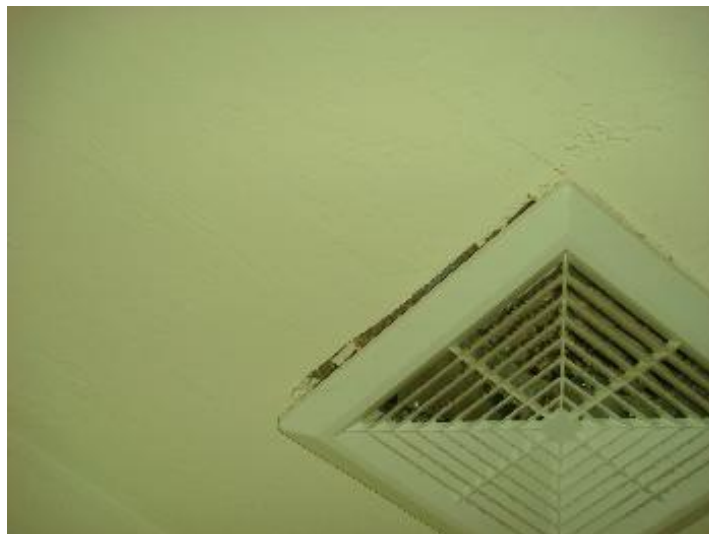
Observations: The exhaust fans are operational. Recommend routine cleaning to help maintain proper functioning. • The exterior portion of Master bath fan is loose. Recommend securing to ceiling.

The exterior portion of Master bath fan is loose. Recommend securing to ceiling.

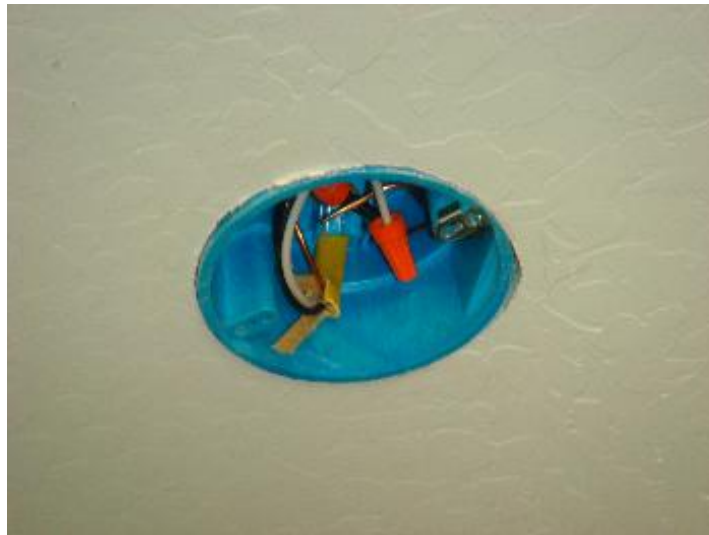
Observations: Ceiling fan outlet doesn't have a cover. Recommend installing a cover to protect electrical wires.

cover missing

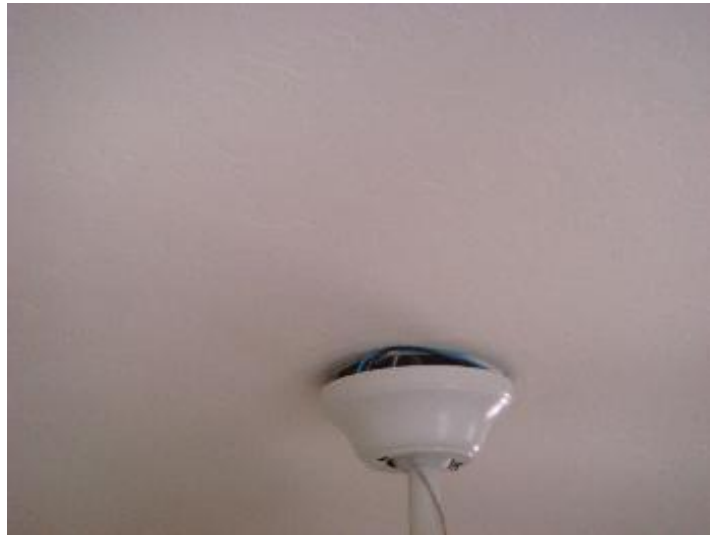
Observations: Outlets are functional. • The ceiling fan base cover is loose in Master bedroom. Recommend properly securing the cover.

The ceiling fan base cover is loose. Recommend properly securing the cover.
